## CASE STUDY

## UV CIPP METHOD USED TO SUCCESSFULLY REHABILITATE EGG-SHAPED BRICK SEWER BENEATH HISTORIC MAIN STREET IN SACO, MAINE

Size, Shape and Conditions of this Sewer Well Matched for the Ultra Violet Curing Process

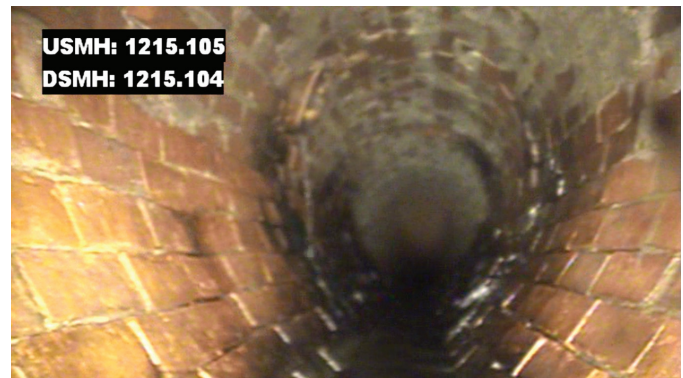
Before: CCTV inspection of the egg-shaped brick sewer prior UV CIPP lining process.

In 2014, a localized failure and collapse was repaired and consequently discussions of long-term solutions began for the City of Saco, Maine. After CCTV inspection along Main Street, it was discovered that just over 1,800 linear feet of brick sewer, ranging in depths from ten to over fifteen feet was deteriorated past its design life. Deterioration was found throughout the length of the sewer and where they also discovered that many of the old sewer's bricks were missing, as well.

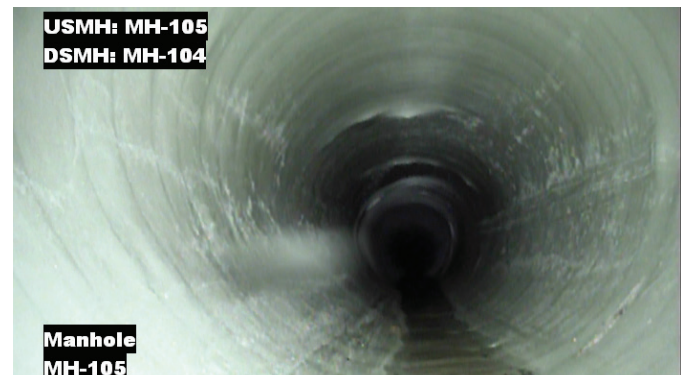
After: Post installation footage shows a complete cure and how the UV cured liner conforms to shape of the brick sewer.

Rehabilitation began in the fall of 2017. After cleaning and prepping the old sewer, the installation team set up a motorized conveyor load system over the entry manhole. The chosen liner was a seamless liner spirally manufactured to provide superior structural qualities. The chosen liner system utilized a thin HDPE slip-sheet to protect the uncured liner system during installation. Once installed, a high volume low pressure blower truck inflated the uncured liner. After the liner is inflated, the UV light train is installed, and a CCTV pre-inspection is performed to ensure the liner is ready for curing. Critical to the success of every UV-CIPP project is the speed at which the light train is pulled through the pipe by the cure truck. This is predetermined based on the pipe's dimensions, liner thickness and environmental conditions. Lastly, the inner protective film is removed after curing and the newly rehabilitated sewer is returned to full service.

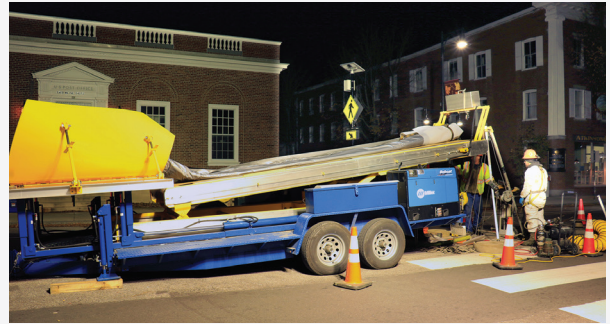
*UV-CIPP liner preparing to be inserted into the egg-shaped brick sewer, through a manhole. No digging was required.*

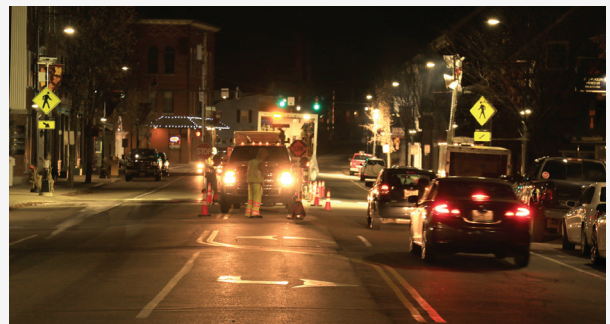
*Small construction footprint needed by UV-CIPP process allows streets to remain open.*
