## UNION PACIFIC M-19A WET WELL REHABILITATION

### Structure Guard®, 100% Solids Epoxy Rehabs Concrete Wet Well Near Union Pacific Rail Yard

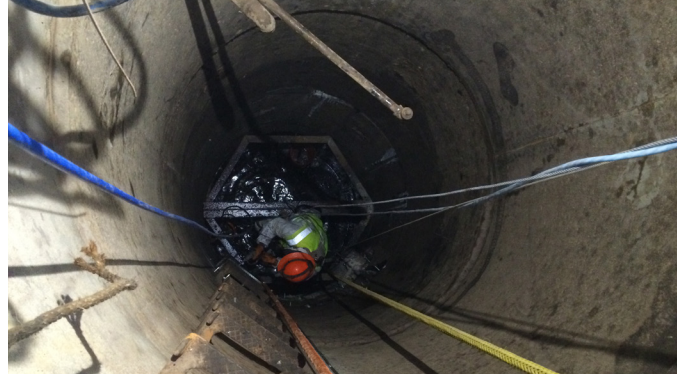
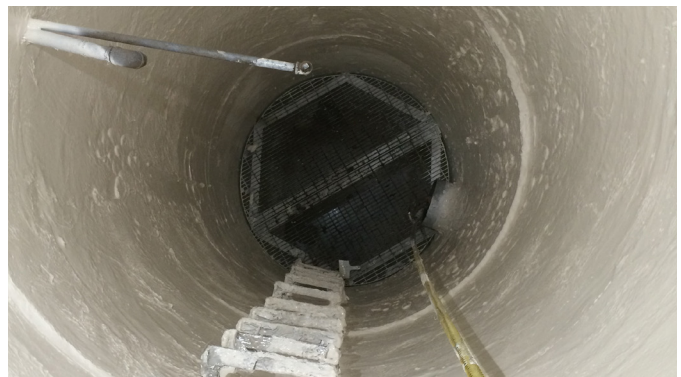
A wet well near one of Union Pacific's rail yards located in Chicago, IL was suffering from major infiltration at the rate of 50,000-95,000 gallons over a time period of 24 hours. The 8'x38', concrete structure, is used to collect storm water, oil and diesel fuel. The infiltration problem was occurring at 12' below ground level. Additionally, the bottom of the wet well was corroded to the point, if left untreated, would have suffered catastrophic failure. Union Pacific also did not want to keep paying to treat the ground water from the infiltration.

After cleaning and power washing the old wet well, a high performance, water stopping grout was used to fill, plug and stop the leaking voids within the wet well. The installation contractor took special care to avoid the hazards of the fast-moving trains still in operation. Once the leaks were plugged, **XX** coats of Structure Guard were then applied and allowed to cure for **XX** hours/days.

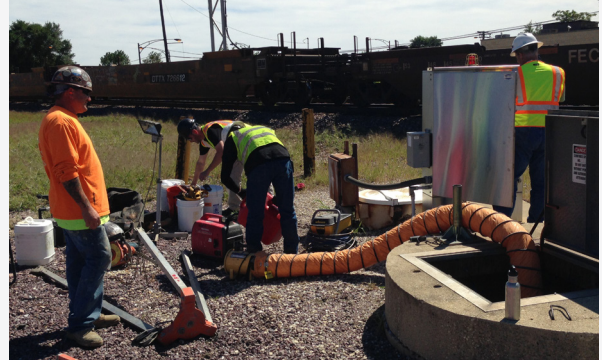
Access to the well will was very close the active rail road.
