# GEOKRETE® GEOPOLYMER OUTPERFORMS ALTERNATIVE SOLUTIONS FOR MANHOLE REHABILITATION

## Pilot test conducted in Cheektowaga, New York finds GeoKrete Geopolymer a superior manhole rehabilitation solution.

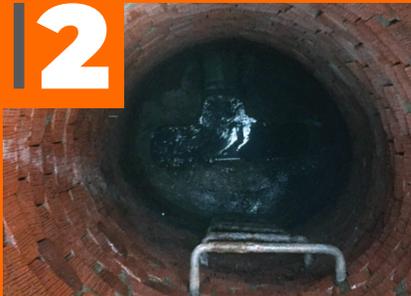
2

Manhole condition prior to GeoKrete geopolymer application.

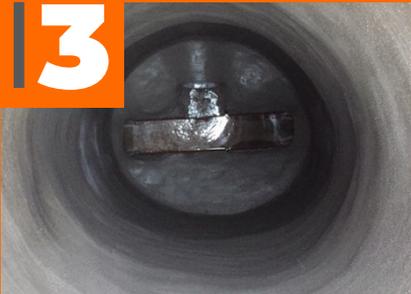
3

GeoKrete Geopolymer showed no signs of cracking and peeling.

The town chose to reline them with a geopolymer lining system called GeoKrete using a spincasting apparatus to ensure a consistent and even coating from top to bottom. In 2016, Rodney Manthey, from the Grand Chute-Menasha West Sewer Commission inspected the same manholes and reported that after 10 years the manholes showed no signs of degradation and were still in like-new condition.

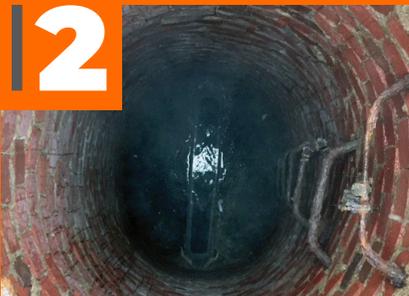
Manhole condition prior to GeoKrete geopolymer application.

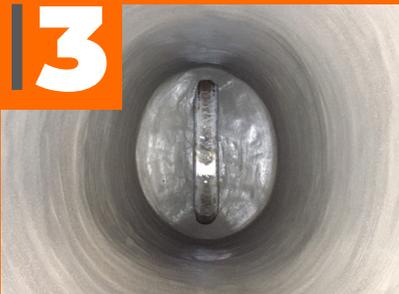
GeoKrete Geopolymer showed no signs of cracking and peeling.
