CASE STUDY

Central Valley Water Reclamation Facility

Structure Guard® Installation Eliminates Costly & Extended Bypass Pumping in Two Days, Saving a Minimum of \$35,000

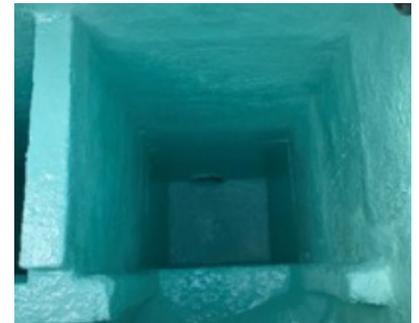
CVWRF's massive plant expansion required the rehabilitation of several thousand feet of large diameter interceptor pipelines, which dropped down into a stipend before extending under the river. Years of adverse conditions, such as high levels of CO₂, H₂S and NH₃ gases and humidity led to the structure's deterioration. Additionally, since it was so close to the river, the only option for repair was trenchless rehabilitation. CVWRF's subcontractor set up a bypass, which was planned to be in place for only two weeks to allow for necessary repairs. However, the bypass was in place for nearly three months - and on pump watch 24/7 at a cost of approximately \$5,000 per day - due to the subcontractor using a urethane coating that didn't suit the needs of the environment and a general misunderstanding of the structure's condition and repair needs.

Years of exposure left the interceptor pipeline and siphons in a highly deteriorated condition.

Within two days, Vortex (in partnership with its certified installation partner Cardinal Coatings) applied Structure Guard®, a 100% solids epoxy coating to provide long-term corrosion protection and structural enhancement. Structure Guard's hydrophobic properties and impermeability to hydrogen sulfide gas also enable it to thrive in moist environments, while ensuring a safe, tenacious bond to whichever substrate it's applied. In contrast, when urethanes are applied in damp conditions, they create a microbubble layer which causes interface and delamination issues that can produce toxic hydrogen sulfide gas and deposit gypsum into the wastewater treatment process.
