Montreal CPP Water Main Relining

**CURED-IN-PLACE PIPE INSTALLATION PROVIDES FULLY
STRUCTURAL REHABILITATION FOR AGING PRESSURE
PIPE BENEATH RAILWAY**

Hyprescon Watermain CIPP Installation

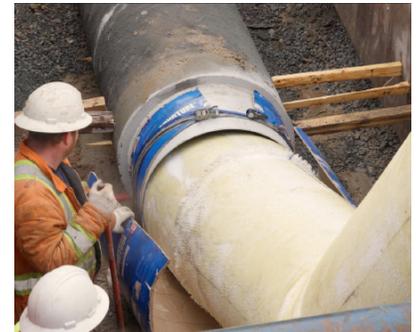
The liner installation portion of the work was completed in only five days.

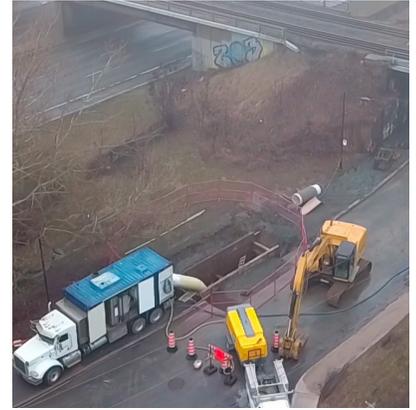
The pipe's location beneath a rail line added higher operational pressure and load design requirements.

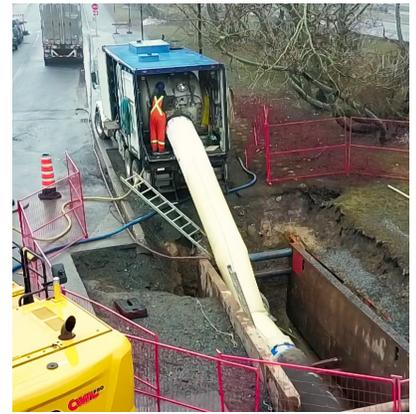
*United**BLUE** CIPP required only minimal excavation, reducing costs and ensuring a faster return to service.*
