PROJECT
BWSC Westside Interceptor

OWNER
Boston Water & Sewer Commission

Brick Sewer Rehab Near Mass General Hospital

PIPE RELINING ELIMINATES NEED TO DIG UP OLD BRICK SEWER NEAR HOSPITAL'S ENTRANCE

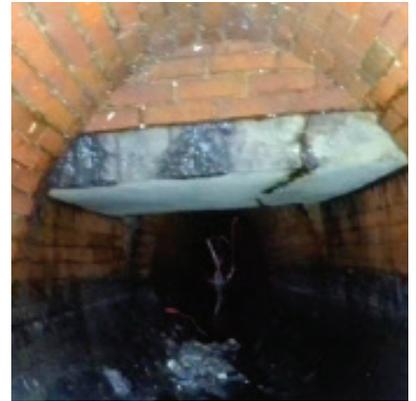
Before: The effects of age and corrosion caused the brick sewer to leak in critical sections of this tunnel, including three headwall obstructions.

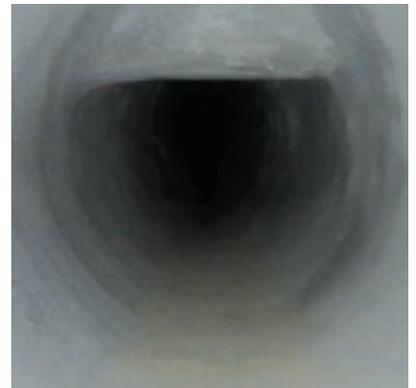
After: 1.75" of QLS GeoKrete was spray-applied to the non-round areas of the tunnel and delivered the required structural and corrosion protection.

Only 1.75" of GeoKrete was needed to achieve the structural requirements. For this application, it was spray applied and then troweled to a smooth finish. The Quadex team completed this portion of the project in one week.

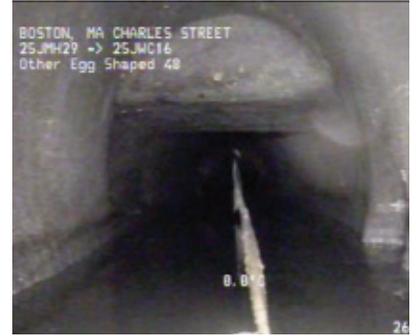
The Boston Water & Sewer Commission inspected the brick sewer one year after the project was completed. There were no visible signs of any degradation and was found to be in the same condition it was after the project was completed.

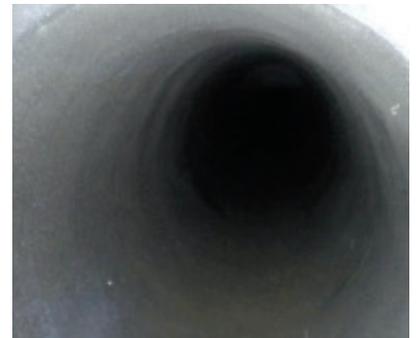
GeoKrete is precision applied in uniform thickness — resulting in a smooth, fully structural finish.

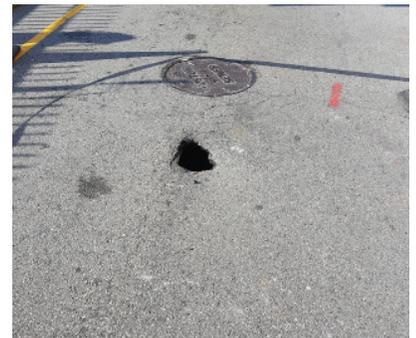
Excessive I & I caused undermining of street.
