CASE STUDY

Denver-Area Water Treatment Facility Uses Structure Guard® – Water to Rehabilitate Leaking and Corroded Flume and Weir

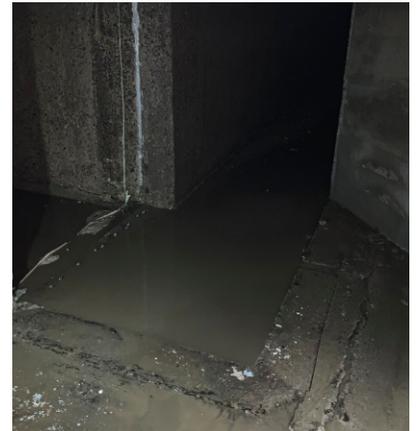
BEFORE: Wastewater Treatment Plant (WWWTP) flume entry had begun to leak around the seams.

The operator of a water treatment facility in Denver, CO was looking for a cost-effective and efficient solution to their failing internal infrastructure. Two areas of particular concern exhibited extreme corrosion and deterioration. The first area was a 100 LF section of a 4' x 4' box shaped potable water flume located above a hallway. Water had begun leaking through multiple seams and puddling on heavily used walkways, creating a safety issue (see picture right). Additionally, they identified a heavily corroded overflow weir used to ensure a uniform flow rate and avoid short-circuiting. The weir was corroded to the point where it was no longer functioning as designed and was impacting the facility's operating efficiencies.

- **Step 1:** High-pressure cleaning and prep of both the flume and weir
- **Step 2:** Fill voids and patch cracks with rapid-set Quadex Hyperform®
- **Step 3:** Spray-apply 80 mils of Structure Guard® - Water
- **Step 4:** Visual inspection, holiday testing and adhesion testing (Pull Test) at 780 psi

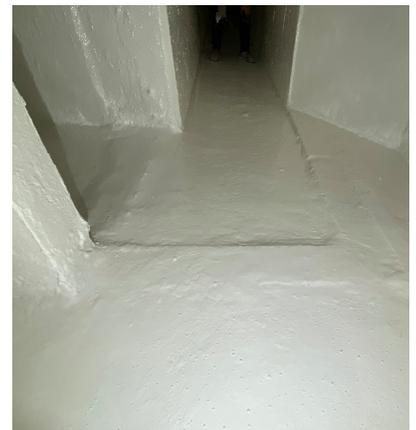
AFTER: WWWTP After patching and sealing leaks with Hyperform®, the flume entry way fully rehabilitated with Structure Guard® - Water.

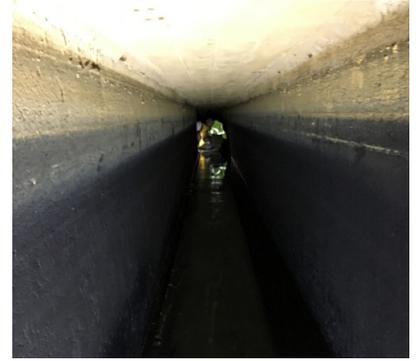
BEFORE: 100LF section of a 4' x 4' boxed-shaped potable water flume was leaking and creating safety issues along the walkway.

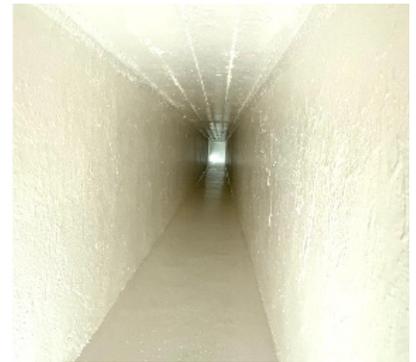
AFTER: After the voids and cracks were sealed with Hyperform®, the flume was coated with 80 mils of Structure Guard - Water for long-term protection.

This contractor recommended an 80 mil thick application of Structure Guard® - Water as the coating and rehabilitation solution for this project. Structure Guard - Water is an NSF-61 approved, one-step self-priming 100% solids epoxy. With a 25-minute pot life and extended re-coat time, there was plenty of time to apply Structure Guard - Water, using an approved plural component sprayer to the specified -80 mil thickness.

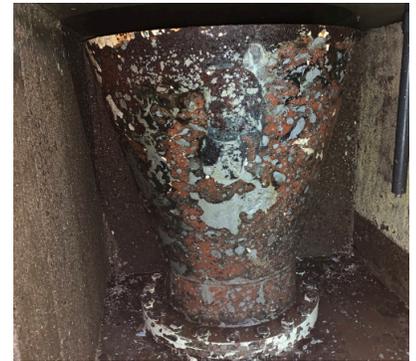
BEFORE: A weir was so corroded it was no longer functioning.

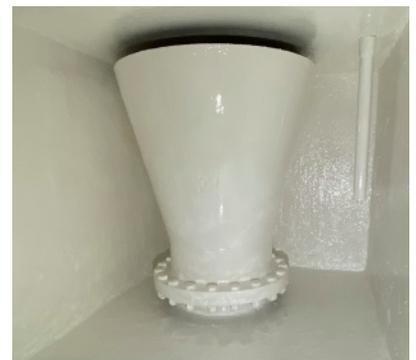
AFTER: Application of Structure Guard - Water at 80 mils thickness.

Once applied with Structure Guard - Water, the coating passed all post-installation testing, including a pull test of 780 psi. Given the extreme corrosion protection properties of this NSF-61 approved 100% solids epoxy, the flume and Weir can once again perform as they were originally designed, while also providing a safe, leak free work environment with dry walkways. Meeting all objectives set forth by the treatment plant engineering team, the project was completed on time and within budget.
