# 10 Sanitary Sewer Manholes Were Corroded From H<sub>2</sub>S Gas Exposure Over Time.

## FAILED T-LOCK LINED MANHOLES REHABILITATED WITH STRUCTURE GUARD® 100% SOLIDS EPOXY

City of Peoria Manhole Rehabilitation

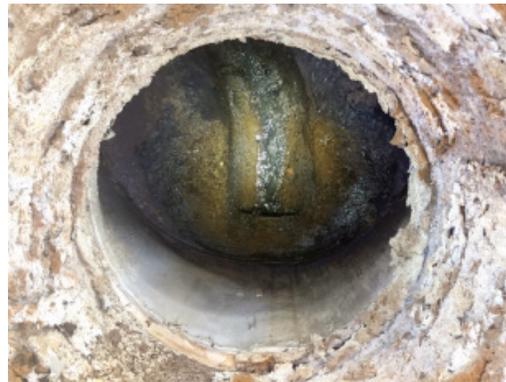
10 T-Lock lined manholes that failed and corroded behind the liner

Before

Over a period of twelve days, all 10 manholes were stripped of T-Lock, cleaned, prepped and then lined with Structure Guard®, which was hand nozzle spray applied to a 250 mil thickness for maximum corrosion and leak protection. Hunter Contracting utilized its sprayMASTER® II Polymeric Lining Rig developed by the Vortex Companies, to perform the job. The sprayMASTER® II is a completely self-contained system built onto a trailer. It's ability to both mix and pump out of the same trailer is not only safer, but requires less equipment and a smaller construction footprint.

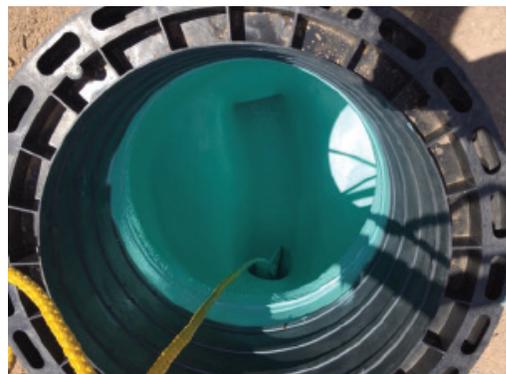
After
