- Niagara Hydroelectric Plant, Vinton, VA
- Original construction in mid-1950's

Penstock Restoration

# Failing Penstocks, Steep Slopes Make for Difficult Pipe Rehabilitation

## AEP NIAGARA HYDRO ELECTRIC PLANT 78" AND 66" STEEL PENSTOCKS

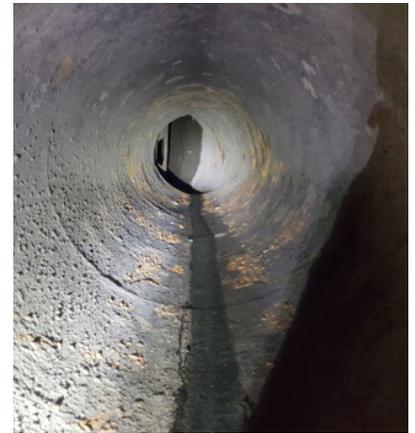
External view of 45° angled penstocks.

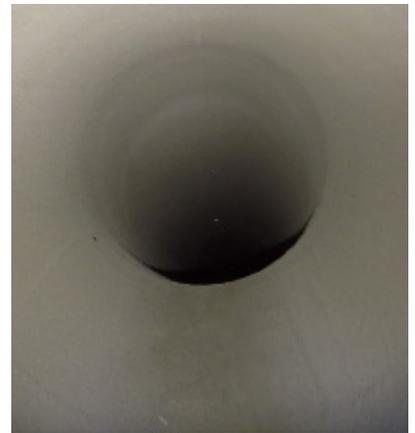
Penstock pipe after GeoKrete® application.

Although the job was unique in the pipe's extreme slope, the application of GeoKrete was not altered. Prior to lining, the failed polyurethane liner was removed and the pipe was prepped and patched where necessary. Ready for application, the QLS sled was able to precisely spin-cast the GeoKrete, at a 1" thickness, onto the inner wall of the penstocks. The application sled is winch-controlled to allow for consistent and uniform application throughout the entire length of the pipe.

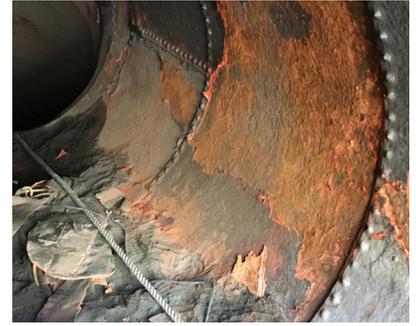
*Urathane removal was tedious.*

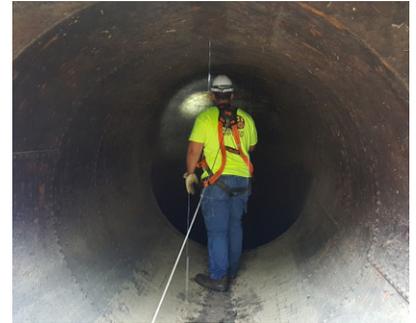
*Peering down the steep slope of penstock.*

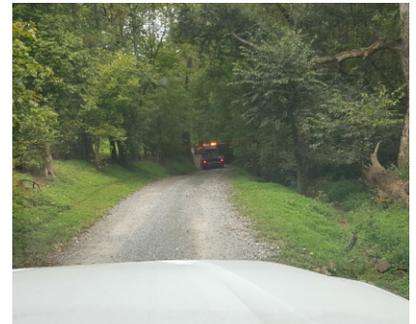
*Remote access and narrow pathways.*

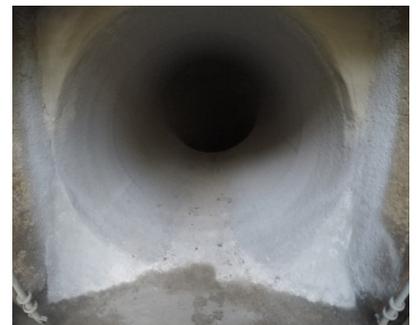
*GeoKrete Liner - Structural renewal and restored flow capacity.*
