CASE STUDY

Rehabilitation of Sewerage Network System: Phase 4 - Eastern Area Contract 2

Sewerage System Rehab and Upgrade Utilizes GeoKrete® for Manholes

GEOKRETE GEOPOLYMER THE PREFERRED CHOICE TO REHAB 40 MANHOLES IN SINGAPORE

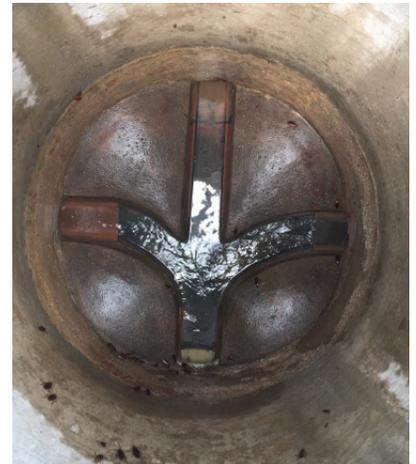
Manhole Before

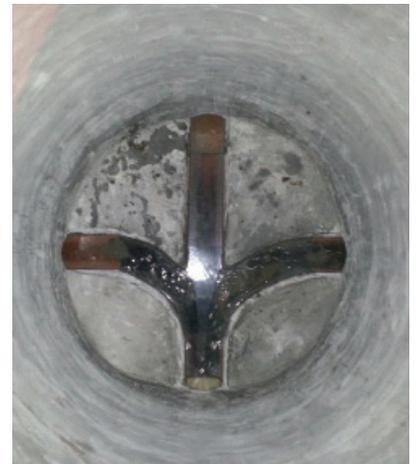
Manhole After

Quadex®'s GeoKrete® Geopolymer spray-applied to 1/2" | 2mm thickness to achieve desired structural integrity and corrosion protection. Troweled to a smooth finish.

The workers particularly liked the ease of application and the lack of "fall-down" of GeoKrete when compared to other materials. GeoKrete® Geopolymer also performed well in third Party Testing and the contractor, PMPS Liner Technologies, also demonstrated how easy it was to apply. With those two important factors, GeoKrete was approved. All 40 manholes were rehabilitated over a four month period. To ensure a smooth and consistent wall thickness, a special designed, chain driven, spin-casting spray apparatus was developed. Mounted on a tripod, then centered over the manhole opening, the apparatus is lowered, then raised up and down the manhole until the desired thickness is achieved.
