Wet Well M-19-A at Union Pacific Rail Yard, Chicago, IL

Structure Guard®, 100% Solids Epoxy Rehabilitates Concrete Wet Well Near Union Pacific Rail Yard

UNION PACIFIC M-19A WET WELL REHABILITATION

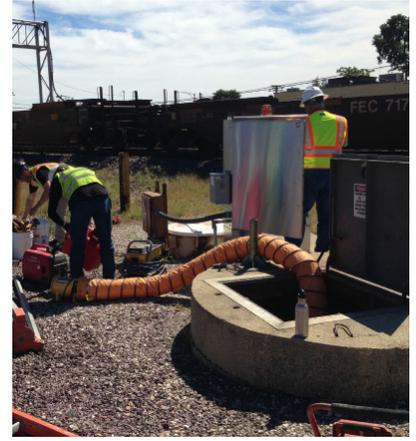
Access to the well will was very close the active rail road.
