GeoKrete® Geopolymer Mortar

For raw, storm, wastewater, and water infrastructure rehabilitation.

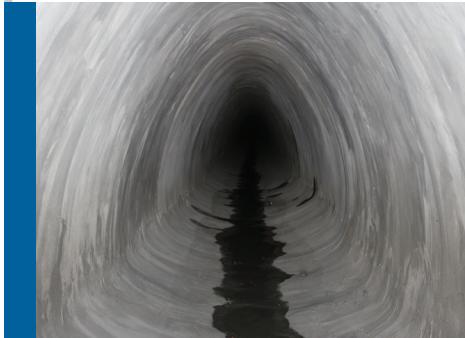
129' DEEP MANHOLE/350' EGG-SHAPED CULVERT REHABILITATION

Problem:
A 129' deep brick manhole constructed in 1912, along with a 350' of 78"H x 66"W brick culvert built in 1915, had reached the end of their useful lives and were in a state of imminent failure.

The Quadex Lining System® featuring GeoKrete geopolymer. Installation thickness optimized applying varying thicknesses ranging from 1" to 3" to provide a fully structural renewal and eliminate I&I.

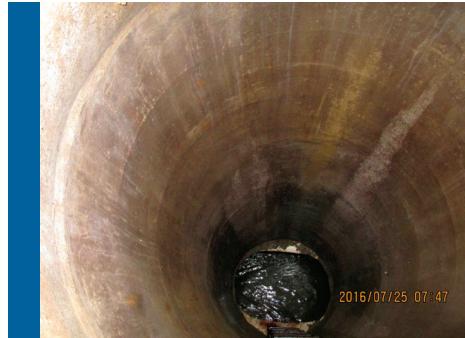
10-YEAR FOLLOW-UP ON GEOKRETE LINED MANHOLES

Problem:
15 manholes located in Northern Wisconsin, previously coated with a polyurea, were already failing after one year. Extensive flaking and peeling was present indicating a complete failure was imminent.

Quadex® GeoKrete geopolymer was specified to correct the problem and applied with the spinMASTER® system to ensure a consistent lining from top to bottom. A trowel was then used to smooth-out the finish. Since GeoKrete has a quick cure time, the manholes did not have to be taken out of service.

In 2016 the manholes were re-inspected. There were no signs of failure or degradation.

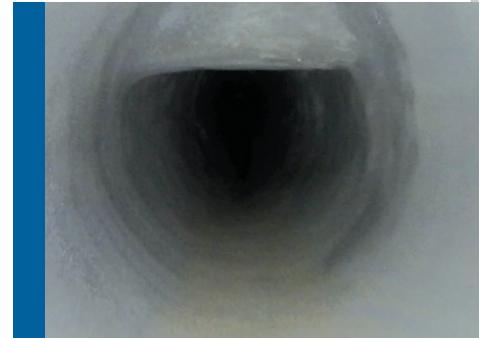
BRICK SEWER REHABILITATION IN FRONT OF BOSTON GENERAL HOSPITAL

Problem:
A section of an old sewer was odd shaped, contained obstructions and could not be CIPP lined. Since it was located near the hospital entrance a trenchless solution was the only option.

The Quadex Lining System, featuring GeoKrete, was used to reline and structurally restore 415' of 54'H x 36'W brick sewer. It was spray-applied to the odd-shaped sewer and was able to cover the obstructions as well.

GeoKrete Geopolymer liner is still in the same condition as the day it was installed.
